Three-Dimensional Echocardiography for the Evaluation of the Left Ventricular Outflow Tract in a Patient with a History of Mitral Valve Replacement

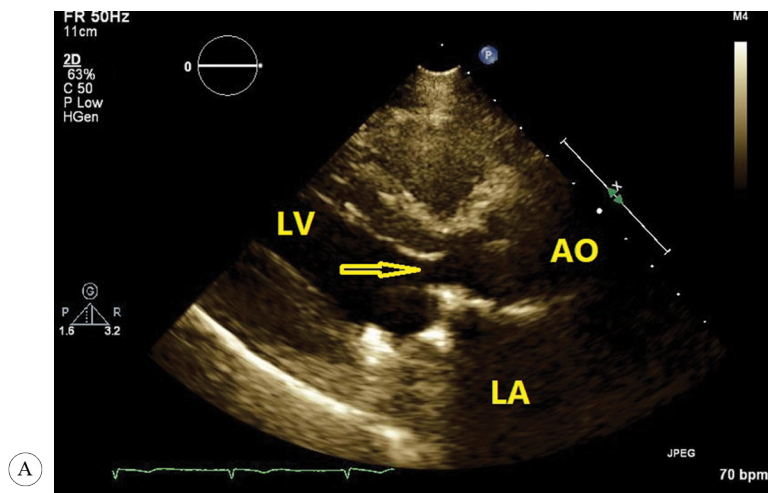
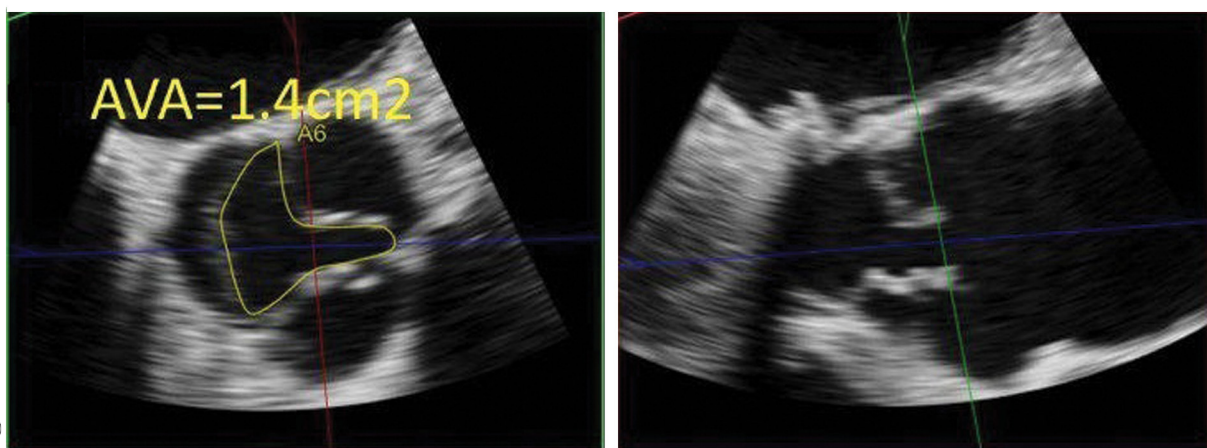
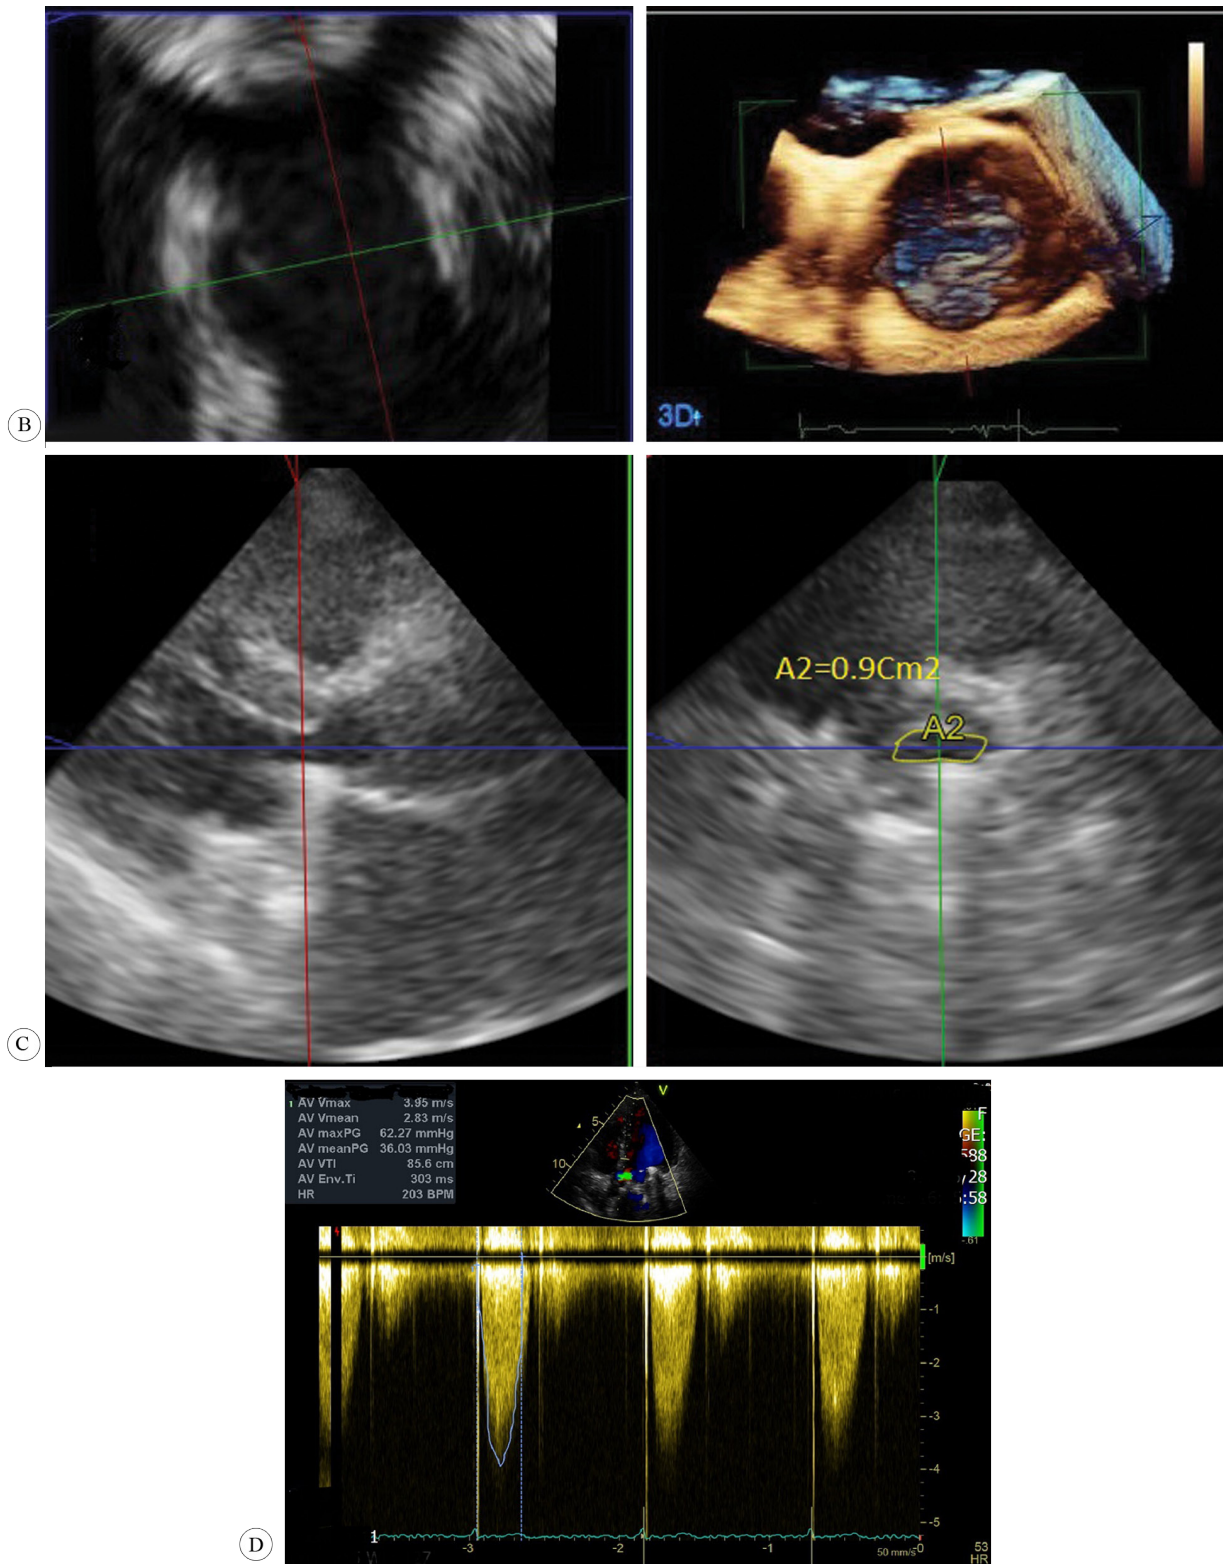
Figure 1. A) Anterior displacement of the mechanical prosthetic mitral valve, resulting in the left ventricular outflow tract (LVOT) narrowing (arrow) in the parasternal long-axis view in transthoracic echocardiography; B) Direct planimetry of the aortic valve in three-dimensional (3D) transesophageal echocardiography in the mid-esophageal short-axis of the aortic valve view; C) Direct planimetry of the LVOT using 3D transthoracic echocardiography in the parasternal long-axis view; and D) The LVOT pressure gradient in the 5-chamber view in transthoracic echocardiography evaluated by continuous wave AO, Ascending aorta; AVA, Aortic valve area; LA, Left atrium; LV, Left ventricle; LVOT, Left ventricular outflow tract

fluoroscopy was normal. Transthoracic and transesophageal echocardiographic examinations demonstrated a left ventricular ejection fraction of 50%, a mechanical prosthetic mitral valve with a normal leaflet motion and acceptable gradients, no visible paravalvular leakage, moderate tricuspid and aortic valve regurgitation, and no tricuspid stenosis. However, there was significant left ventricular outflow tract (LVOT) obstruction (peak pressure gradient=62 mmHg and mean pressure gradient=38 mmHg). For a further evaluation of the aortic valve and the LVOT region, we conducted three-dimensional (3D) echocardiography at the time of transthoracic and transesophageal echocardiography and found that the aortic valve area by direct planimetry was 1.4 cm² and the LVOT area was 0.9 cm² as a result of the anterior displacement of the mitral prosthesis (Figure 1). The reduced aortic valve area did not explain completely what we obtained in the continuous-wave study, so it seems that the main cause was the LVOT obstruction caused by the anterior displacement of the mechanical mitral leaflet, demonstrated by the direct planimetry of the LVOT in 3D echocardiography. The reviewing of the preoperative

transthoracic and transesophageal echocardiographic examinations revealed that there was no aortic valve and LVOT obstruction at that time. The reduced aortic valve area may have been due to a low-flow passing aortic valve because of a significant LVOT obstruction.
